Re: April 2015 Monthly Progress Report
Administrative Settlement Agreement and Order on Consent for Removal Action
U.S. EPA Region 10 Docket No. CERCLA 10-2009-0255
Gasco Sediments Site within the Portland Harbor Superfund Site

Attachment A Monthly Visual Monitoring Report for Pilot Cap Vicinity

Visual Observations Log Form

Monitoring Period: Monthly (Year 9) — April 2015

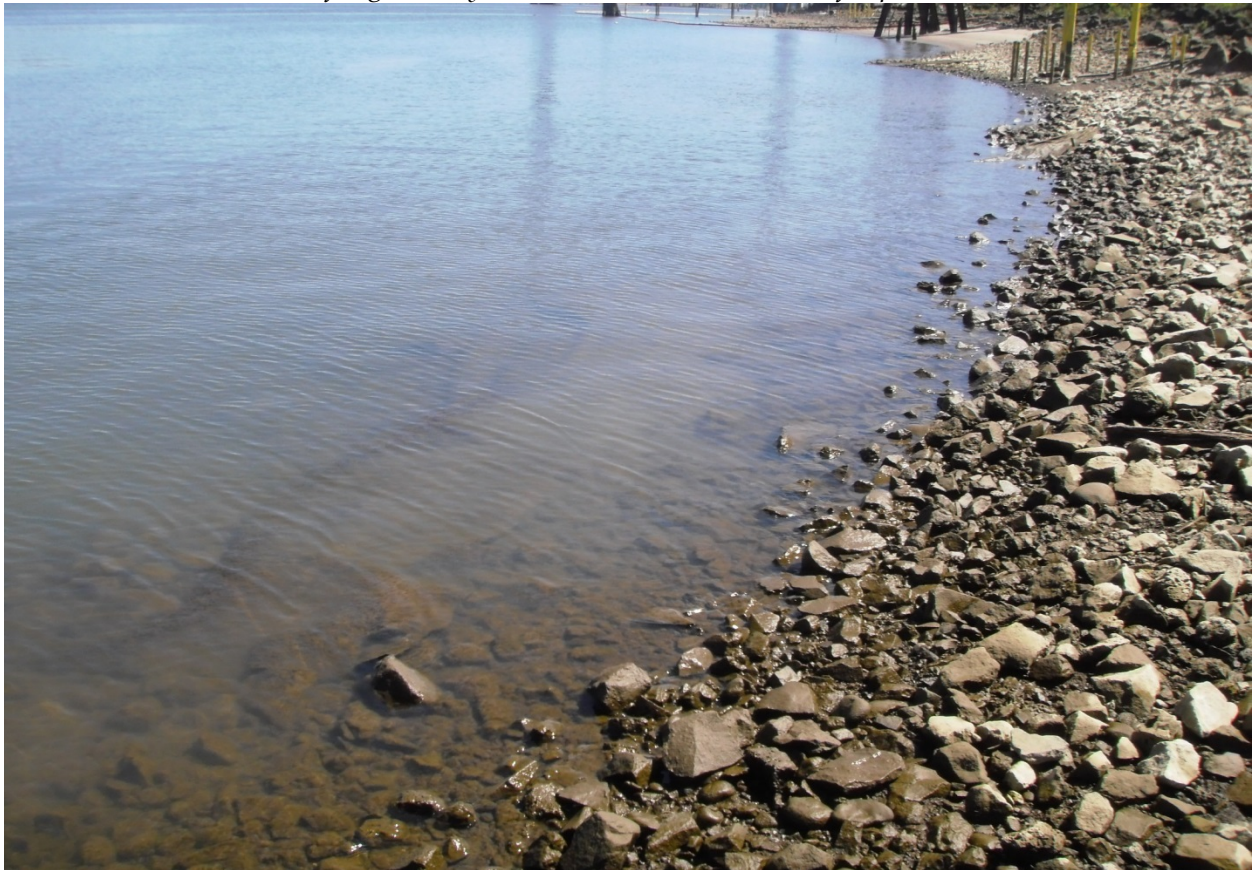
Observations of Erosion/Deposition: All previously noted organo-clay mat material segments are visible. Two segments measuring 1 foot and 5 feet in length are within 2-3 feet of the water's edge near the lateral mid-point of the cap area. A 6-foot section is shoreward of the water's edge located perpendicular to the shoreline at the upriver boundary of the cap. A section of organoclay mat material measuring 40 feet in length is exposed near the downriver extent of the cap at the water's edge with 8-feet of the upriver segment out of water (Photo 1).

Photo 1 — *Visible section of organo-clay mat at the downriver extent of cap area (4/17/15):*

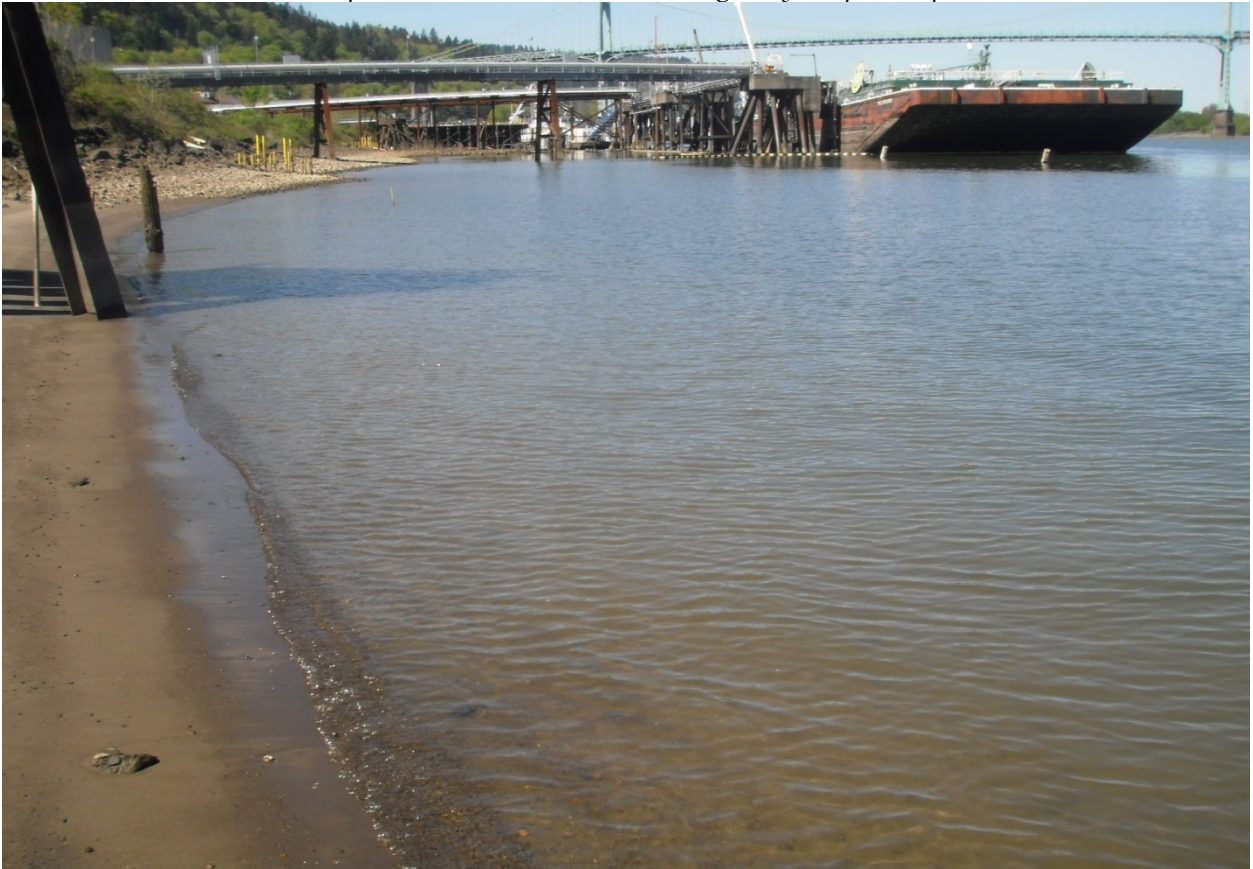
Observations of Long-term Controls (i.e., oil booms, organo-clay mat, etc.) During the observation, a barge was tied at the Fuel and Marine Marketing (FAMM) dock and the FAMM containment boom was placed around the barge during refueling operations. Two buoys that identify the cap area to mariners are in place as installed. The position of the FAMM oil boom, warning buoys, and a general overview of the site shoreline is shown in Photo 2.

Photo 2 — *FAMM oil boom placement and mariner warning buoys at pilot cap area. (4/17/15):*

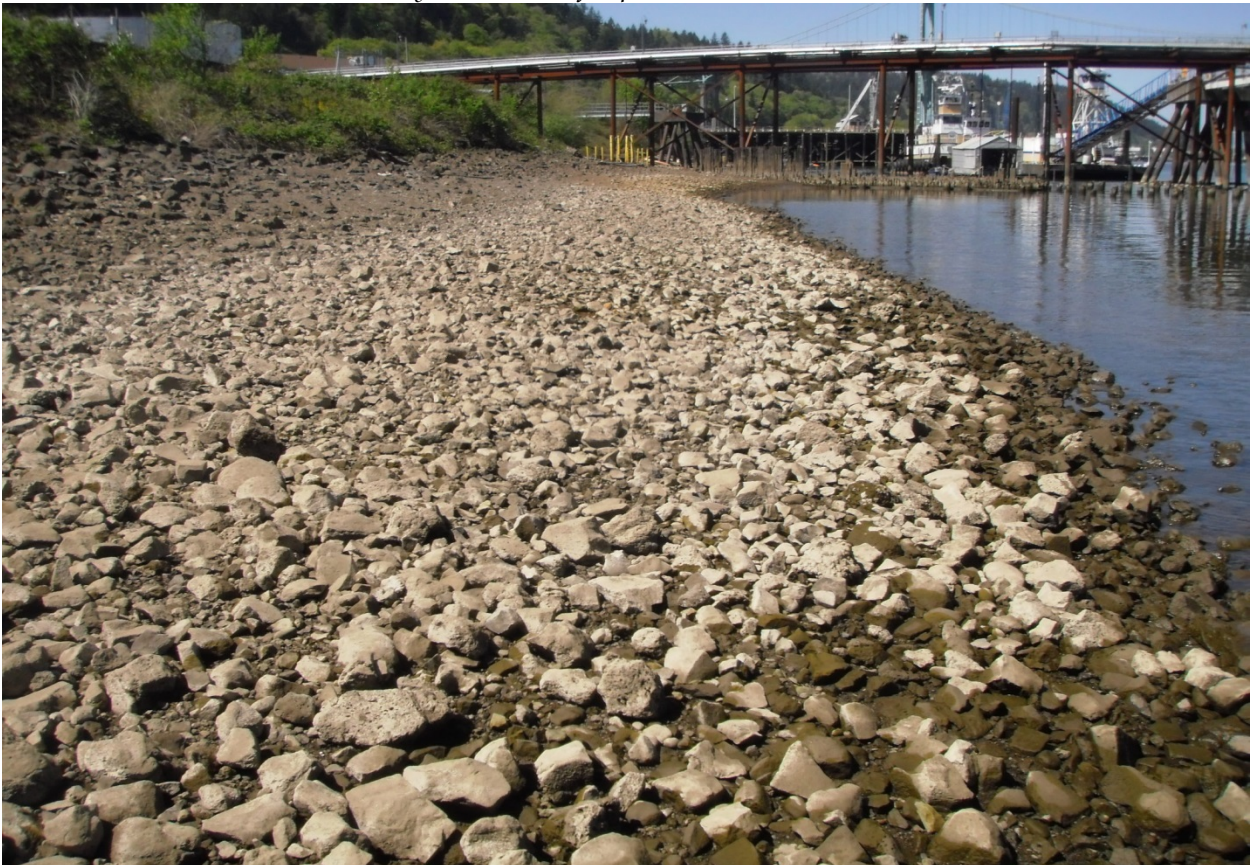
No sheen is evident in or around the cap area. Photo 3 shows the water surface and shoreline immediately downriver of the sediment cap.

Photo 3 — *Conditions immediately downriver of cap area (4/17/15):*
